Manhole Inspection Summary

Manhole # S47CC_031MH

Insp Date: **7/22/08 10:04 AM**

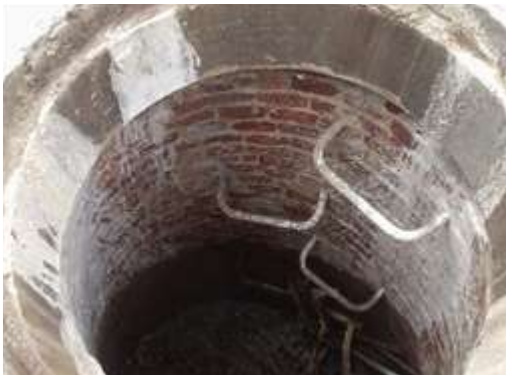
Defect 1

Infiltration: ☐ None ☒ **Joint** ☐ Cracks ☒ **Mortar** ☐ Roots ☐ Wall

infiltration

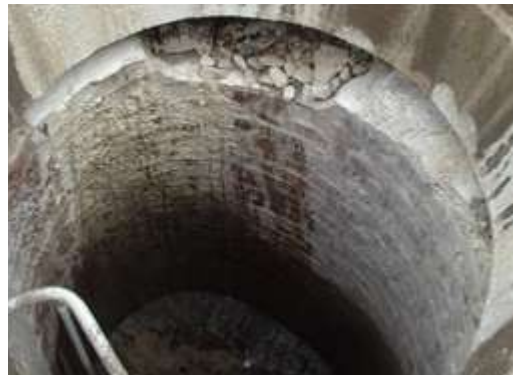
Defect 2

Condition: ☐ Sound ☐ Cracked ☐ Root Intrusion ☒ **Loose Brick** ☐ Deteriorated

loose bricks

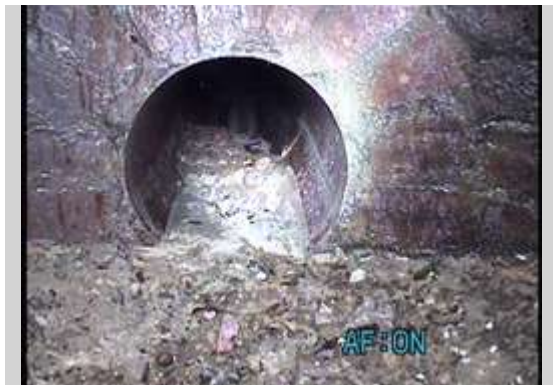
12 O'Clock Outflow

8 in. Circular Gravity Sewer
Pipe Out @ 12 O'Clock

Infiltration: **None** Pipe Seal Cond: **Sound**
